Construction Completion Report Mountain Lake Presidio of San Francisco California

24 March 2014

Prepared for
The Presidio Trust
67 Martinez Street
San Francisco, California 94129-0052

K/J Project No. 1165014*00

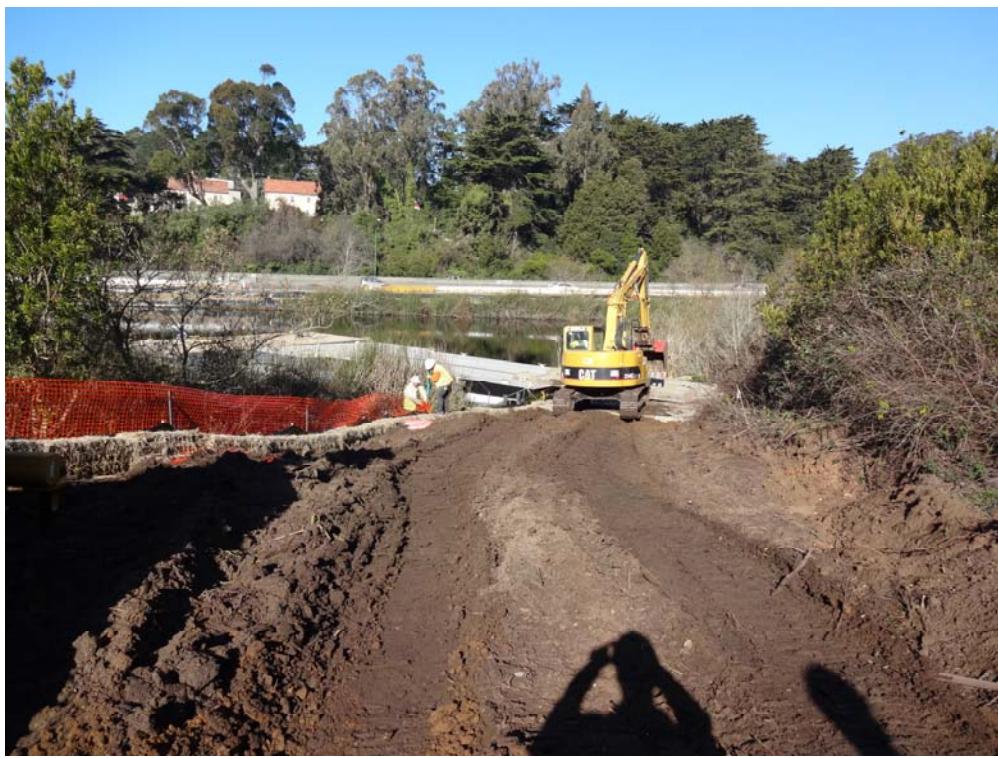
Photo #6: 1-31-2013. Looking northwest at east shore access construction.

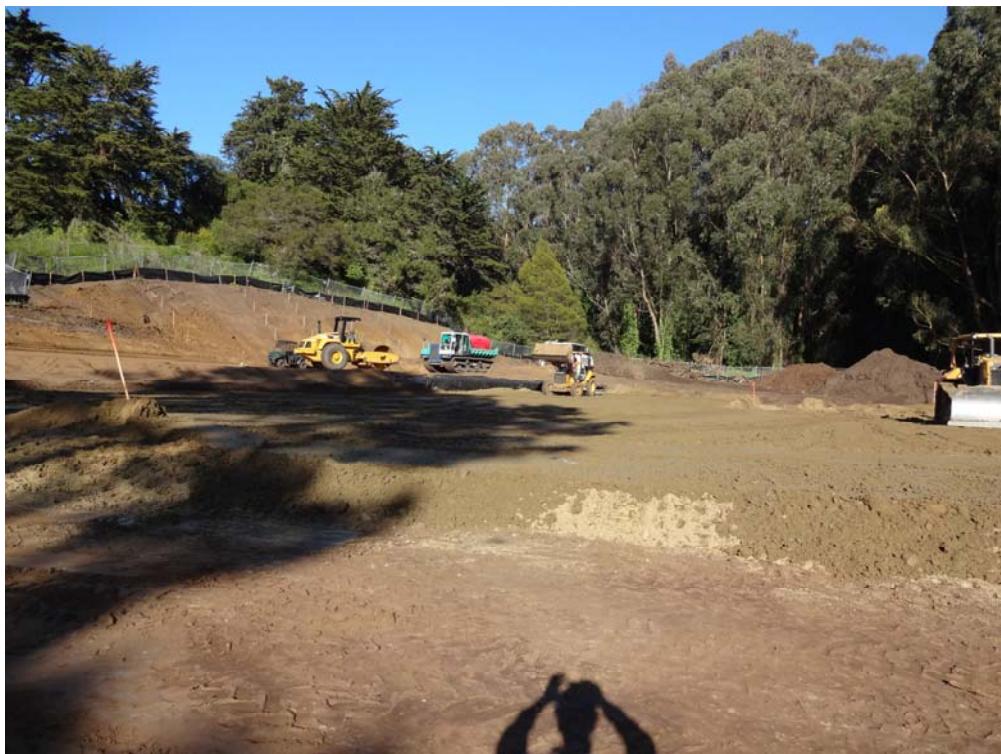
Photo #9: 2-14-2013. MHA during construction.

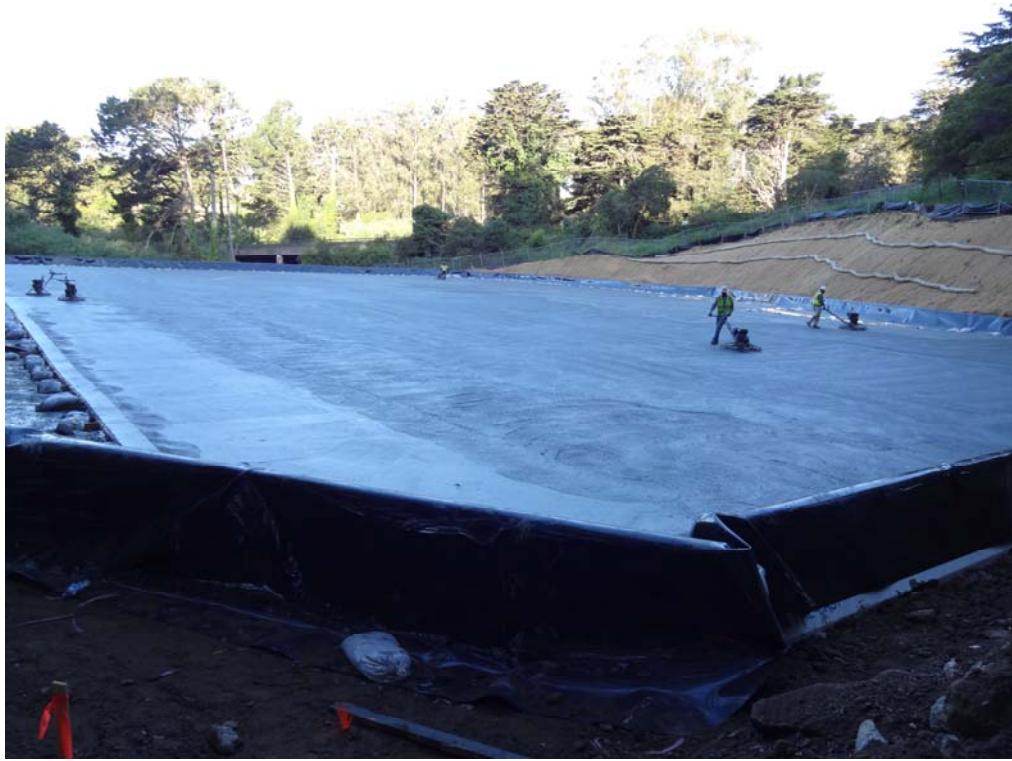
Photo #10: 4-23-2013. MHA after concrete placement.

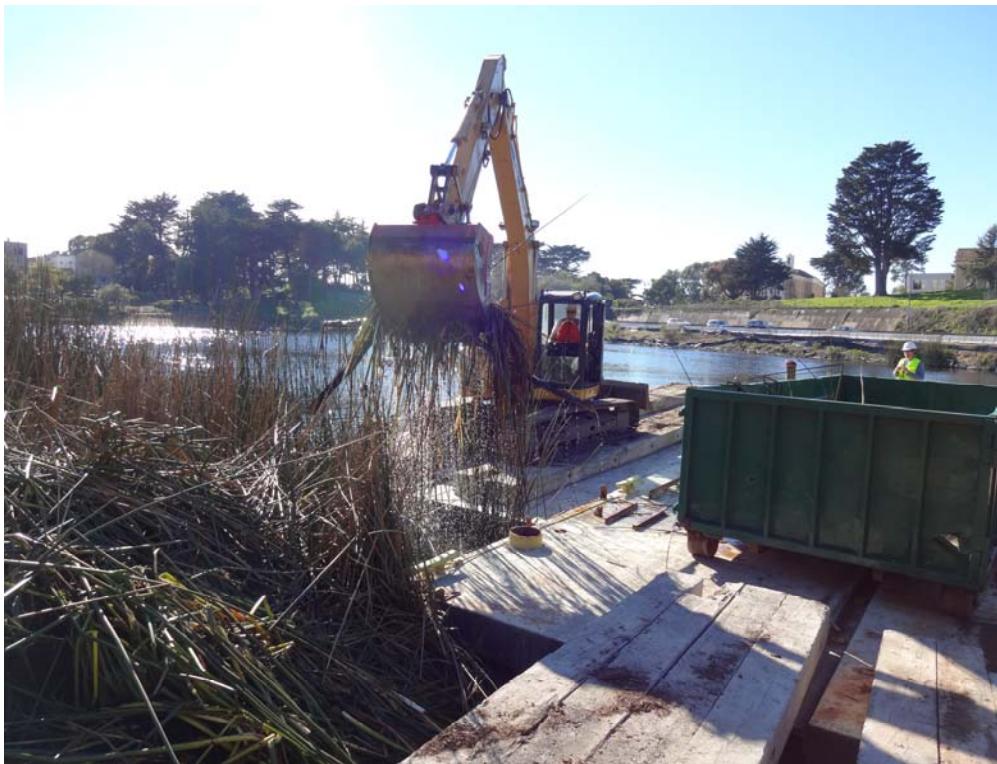
Photo #11: 2-1-2013. Clearing tules adjacent to east shore access.

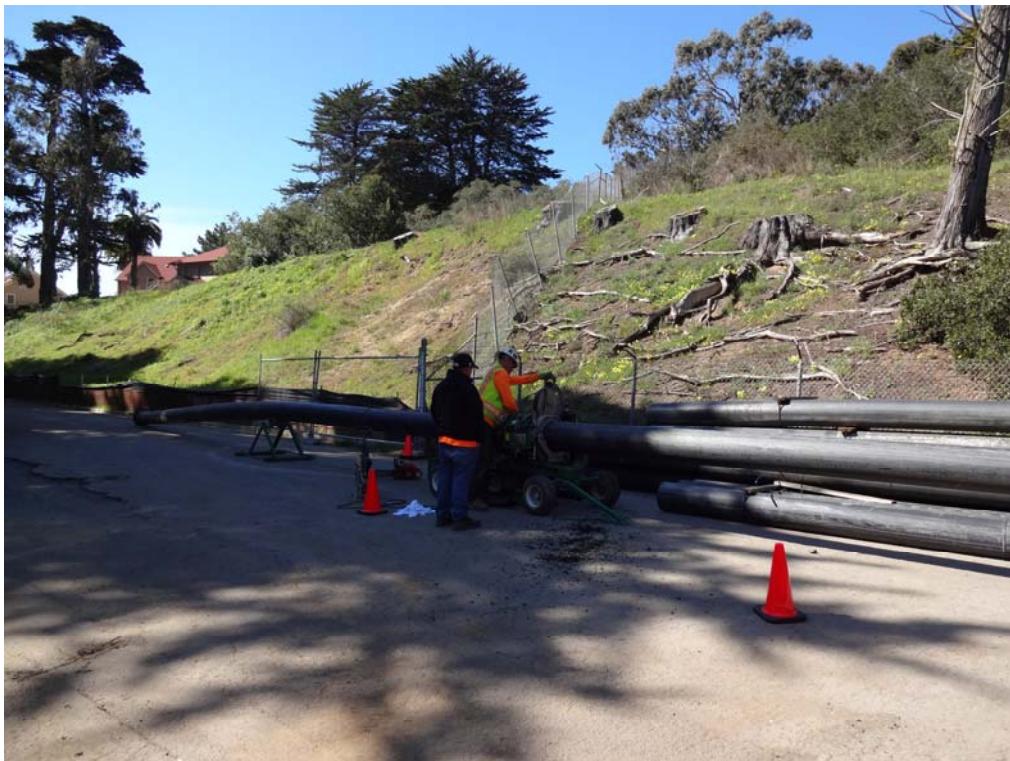
Photo #12: 3-1-2013. Welding HDPE suction dredge line.

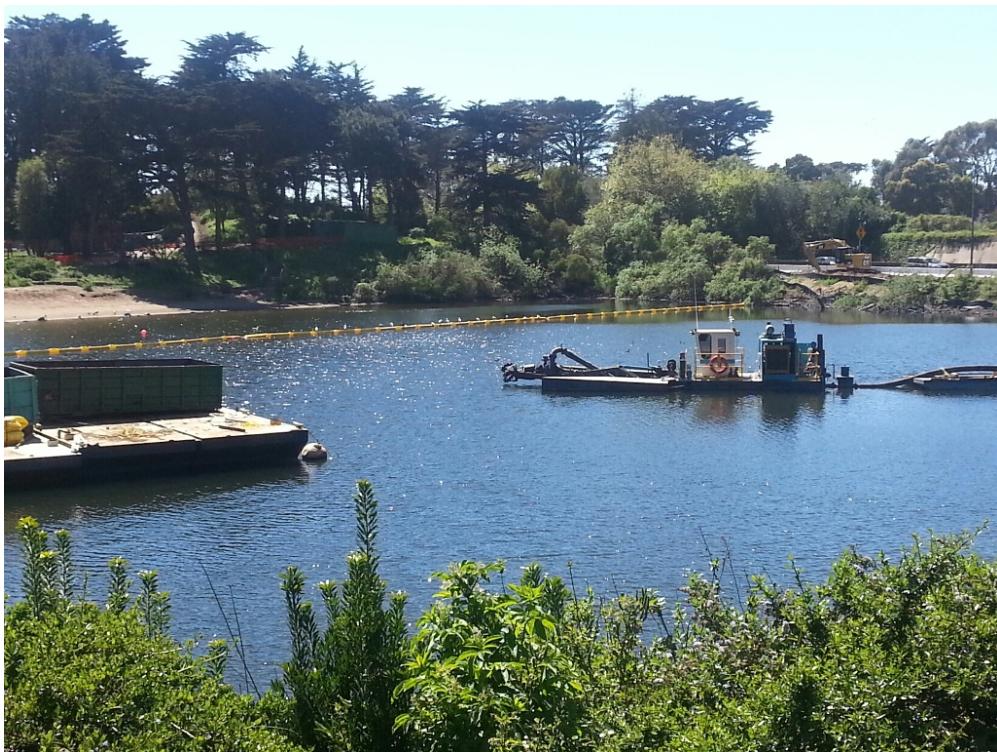
Photo #13: 4-9-2013. View of dredge.

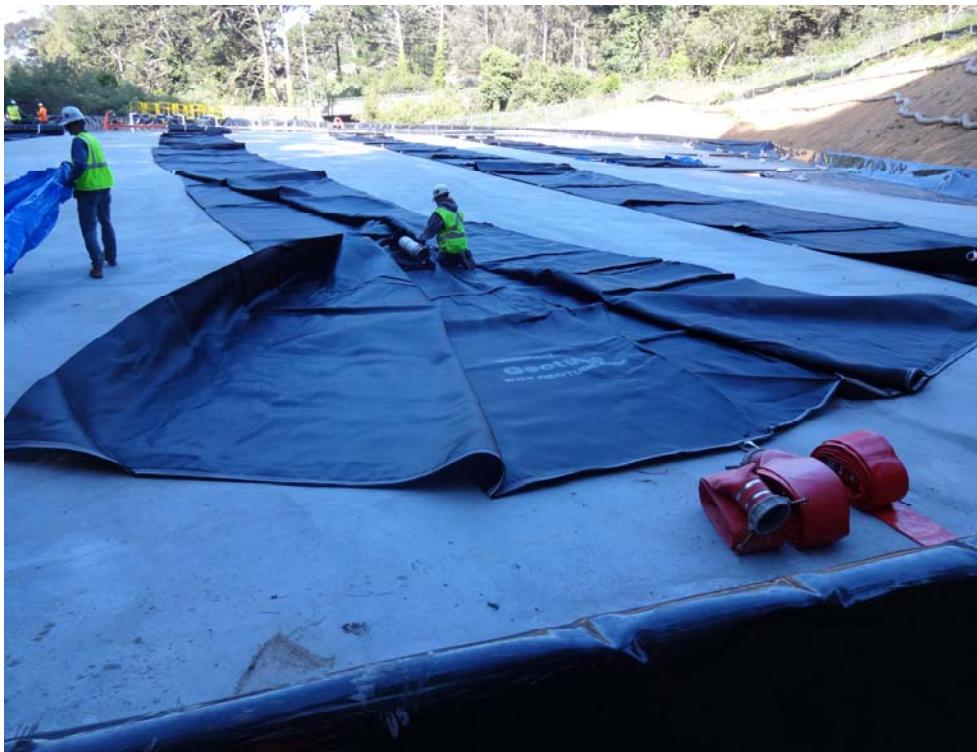
Photo #14: 5-14-2013. Laying out geotextile dewatering tubes.

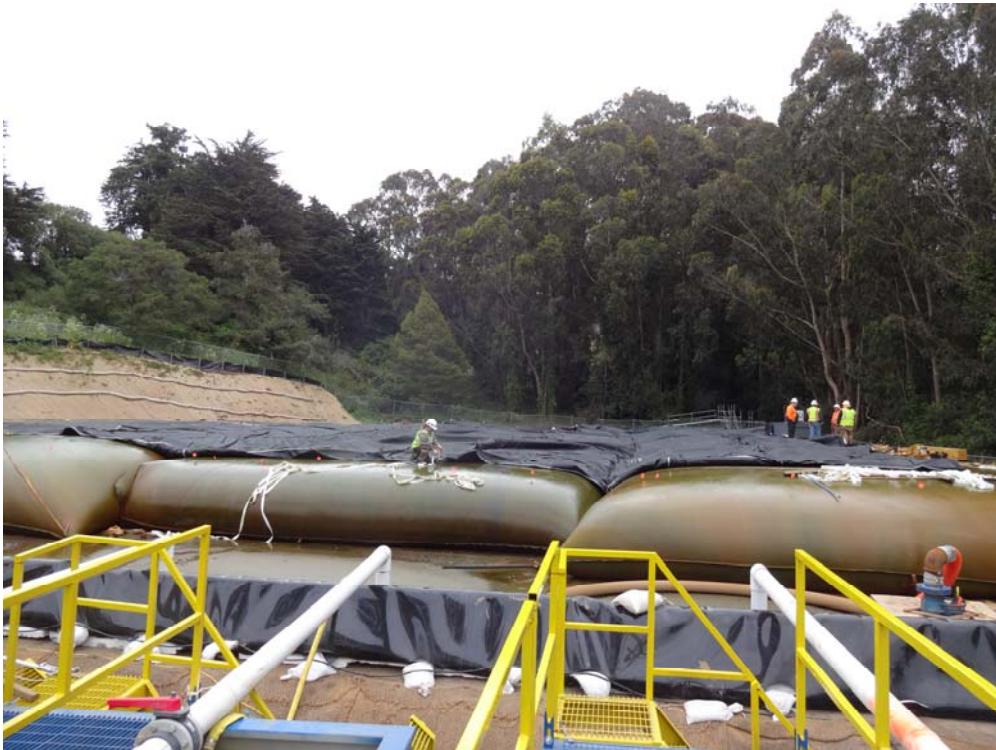
Photo #15: 6-10-2013. Geotextile dewatering tubes in use.

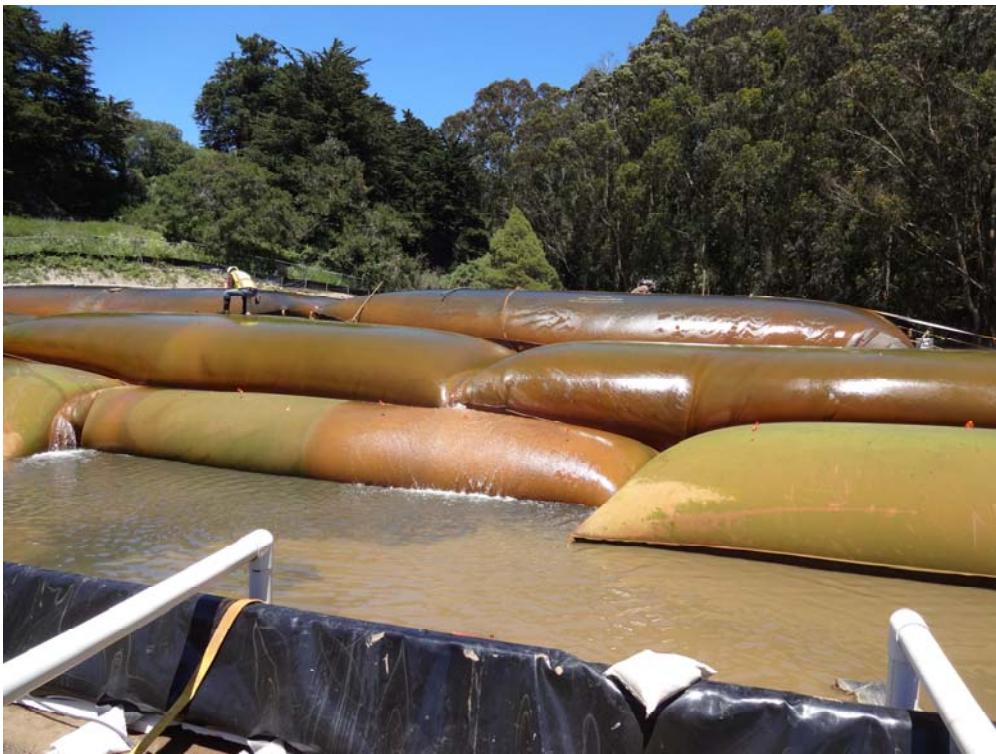
Photo #16: 6-27-2013. Three layers of geotextile dewatering tubes.

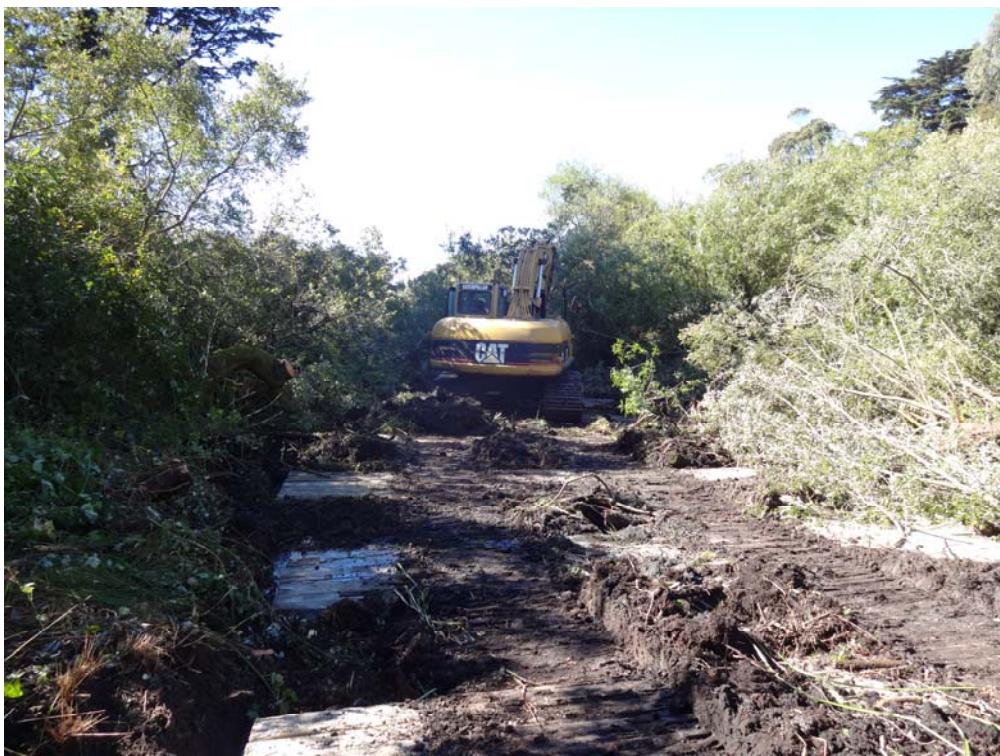
Photo #18: 10-3-2013. Looking south; clearing at North Arm.

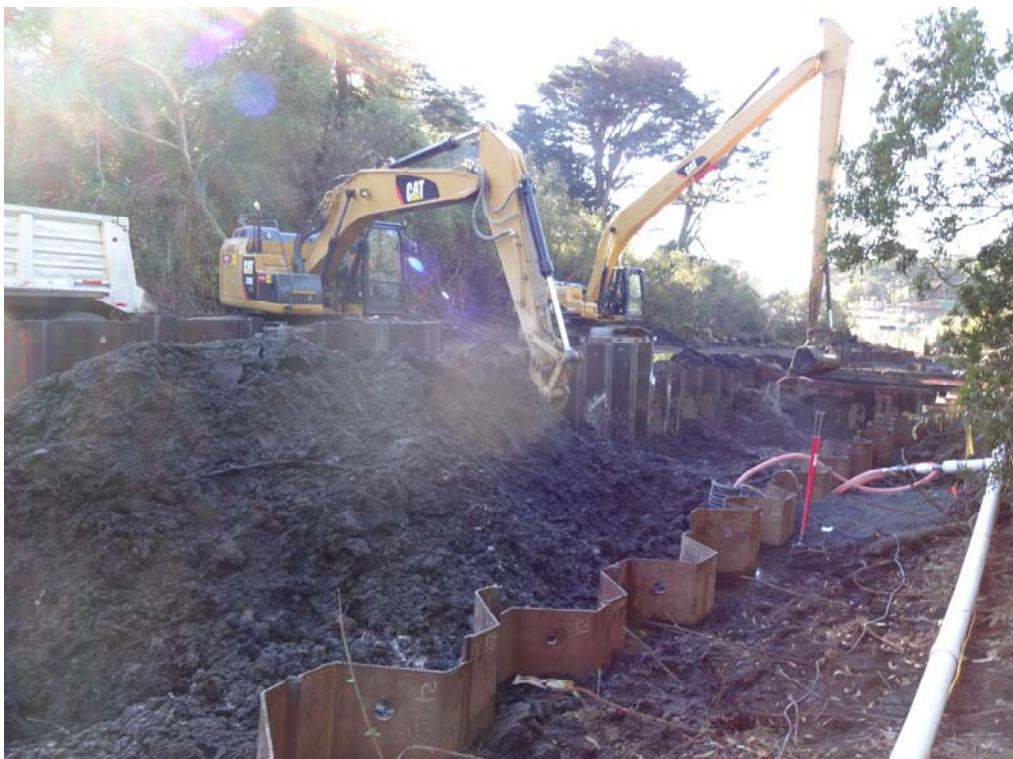
Photo #19: 11-15-2013. Excavating at North Arm. Note sheet piling.

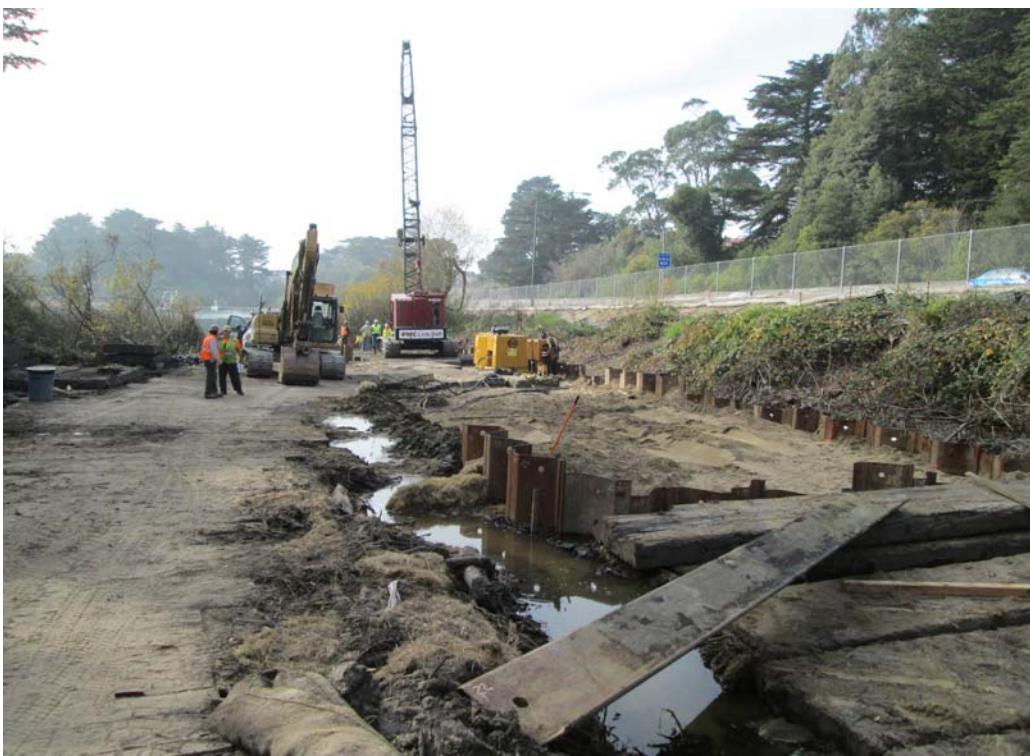
Photo #20: 12-17-2013. North Arm after backfilling.

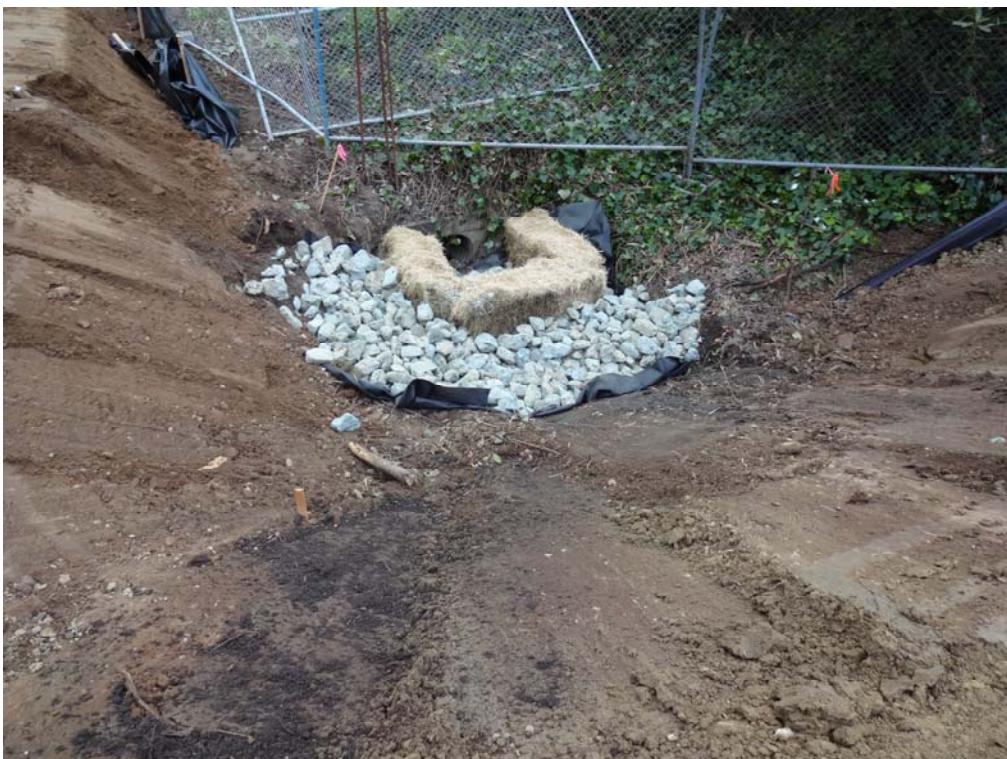
Photo #21: 2-18-2013. Example of water quality protection structure, near MHA.

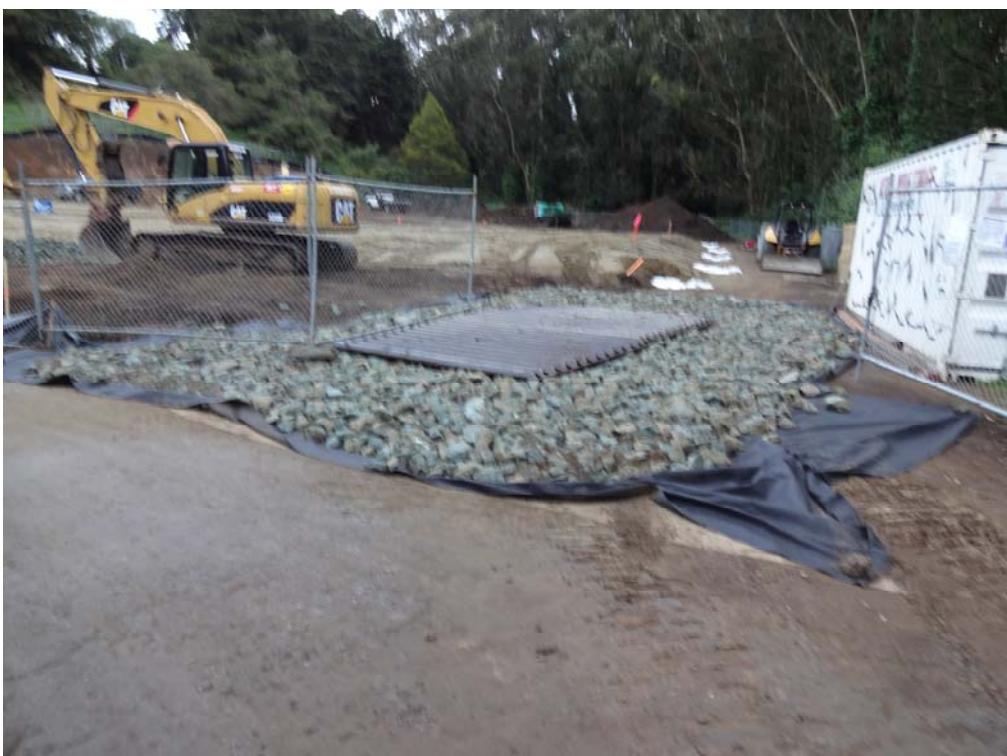
Photo #22: 2-19-2013. Example of water quality protection structure at MHA

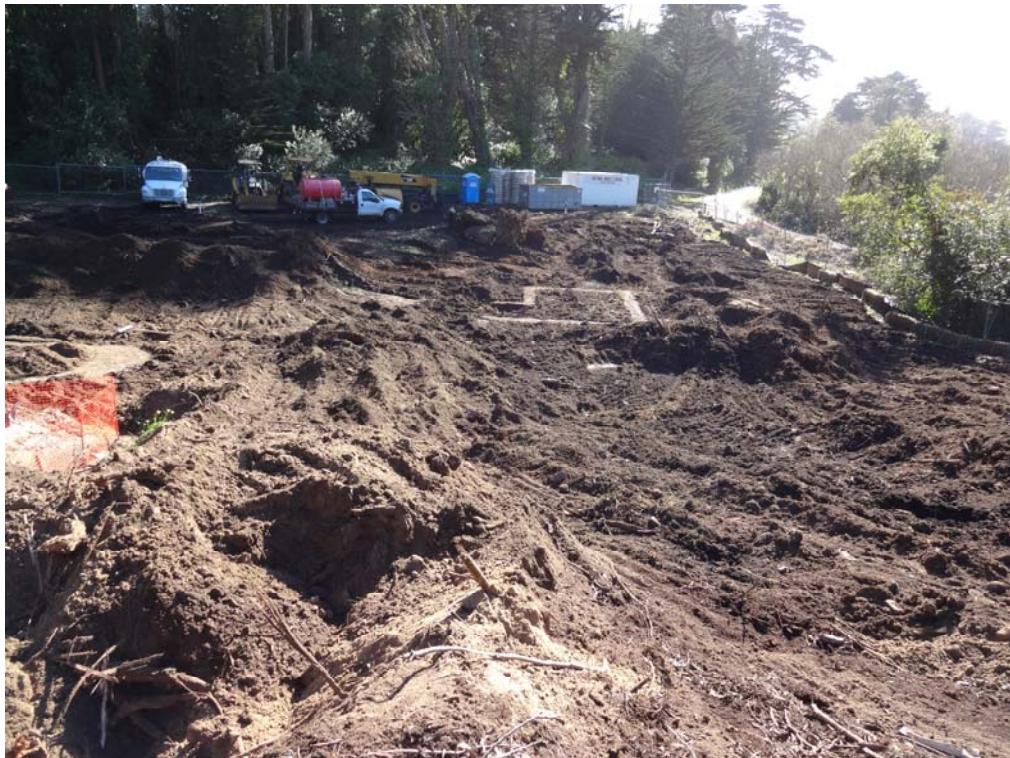
Photo #23: 1-30-2013. Uncovered cultural resource – concrete footing in MHA.

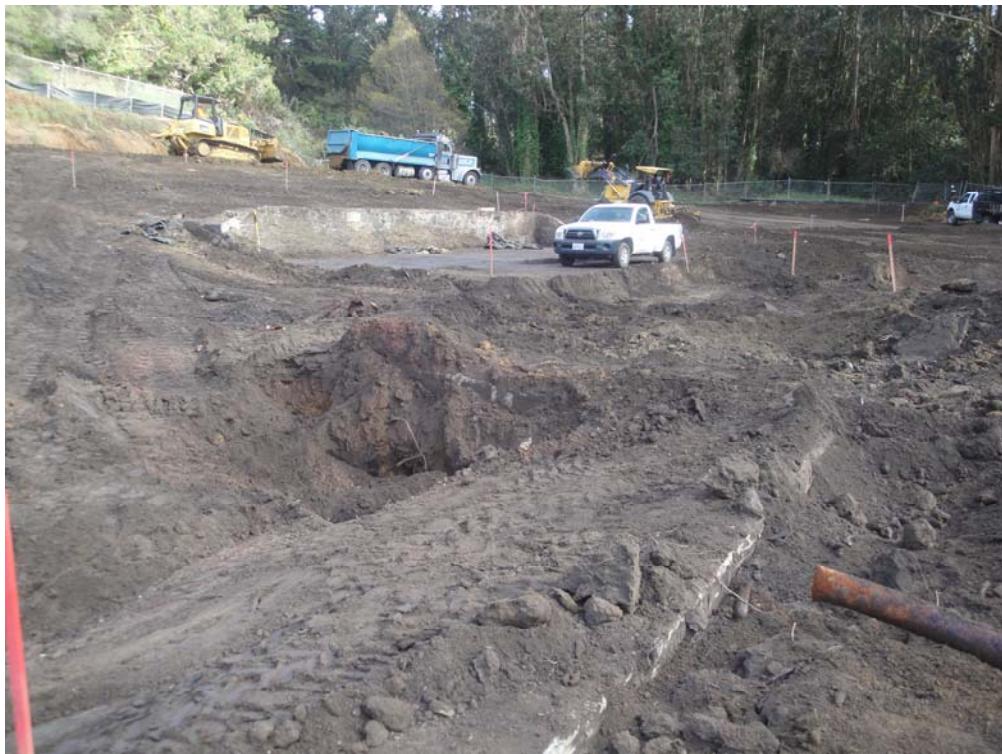
Photo #24: 1-9-2013. Uncovered cultural resource – wall in MHA.

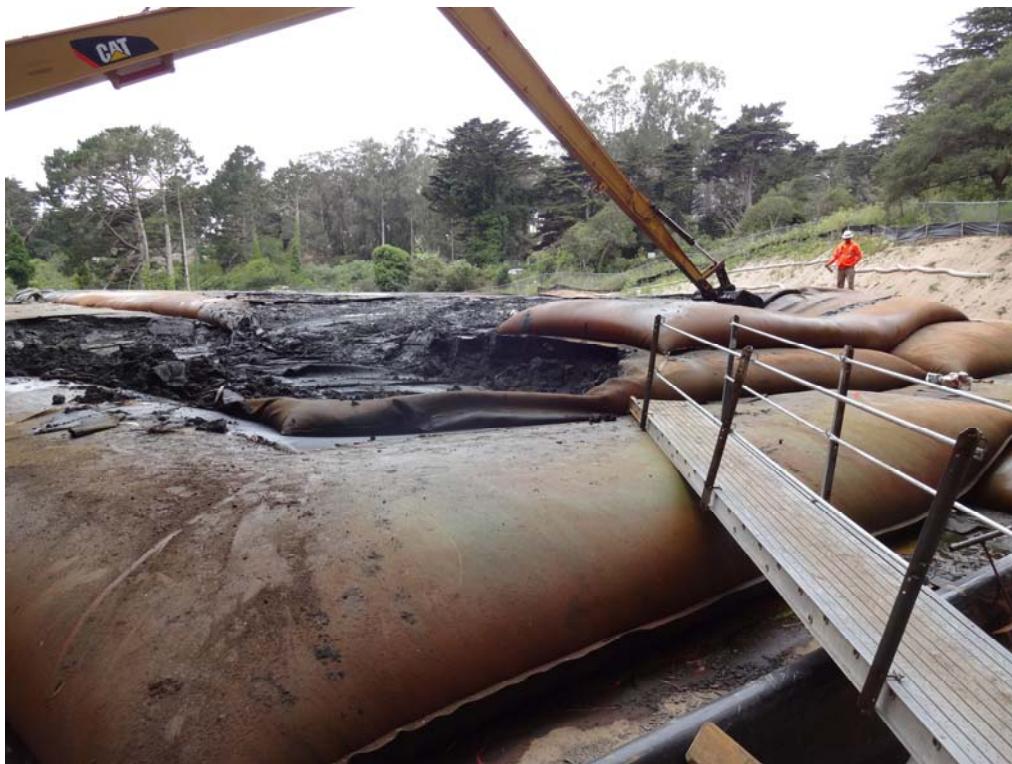
Photo #25: 7-15-2013. Removing sediment-filled dewatered tubes.

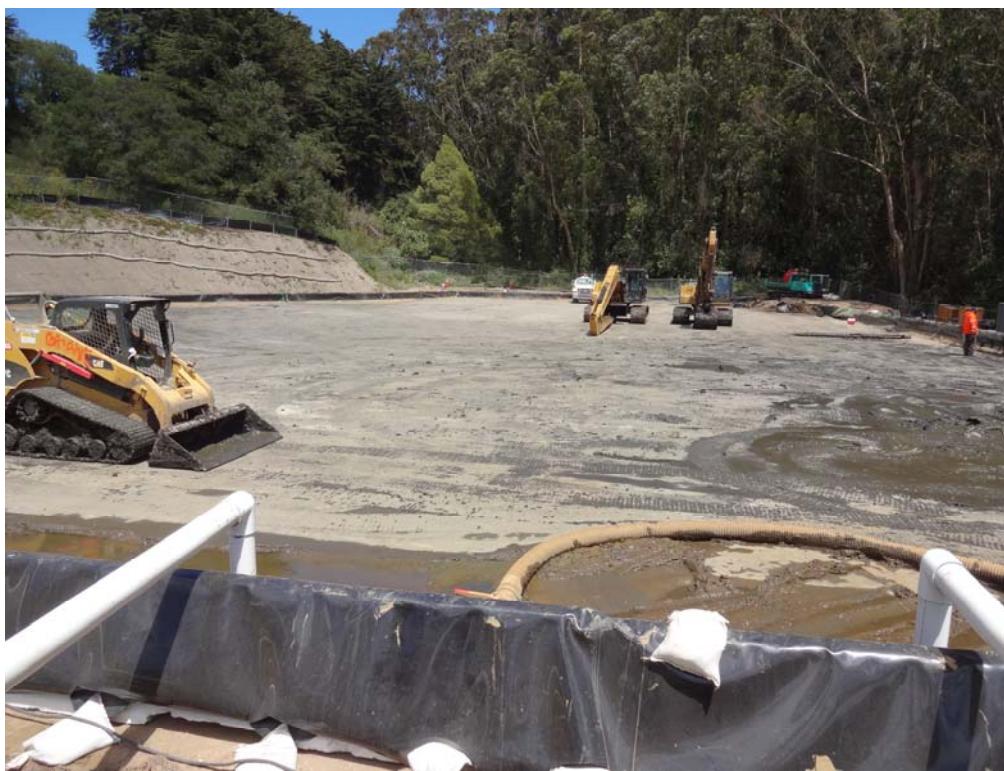
Photo #26: 8-1-2013. MHA after geotextile dewatering tube removed

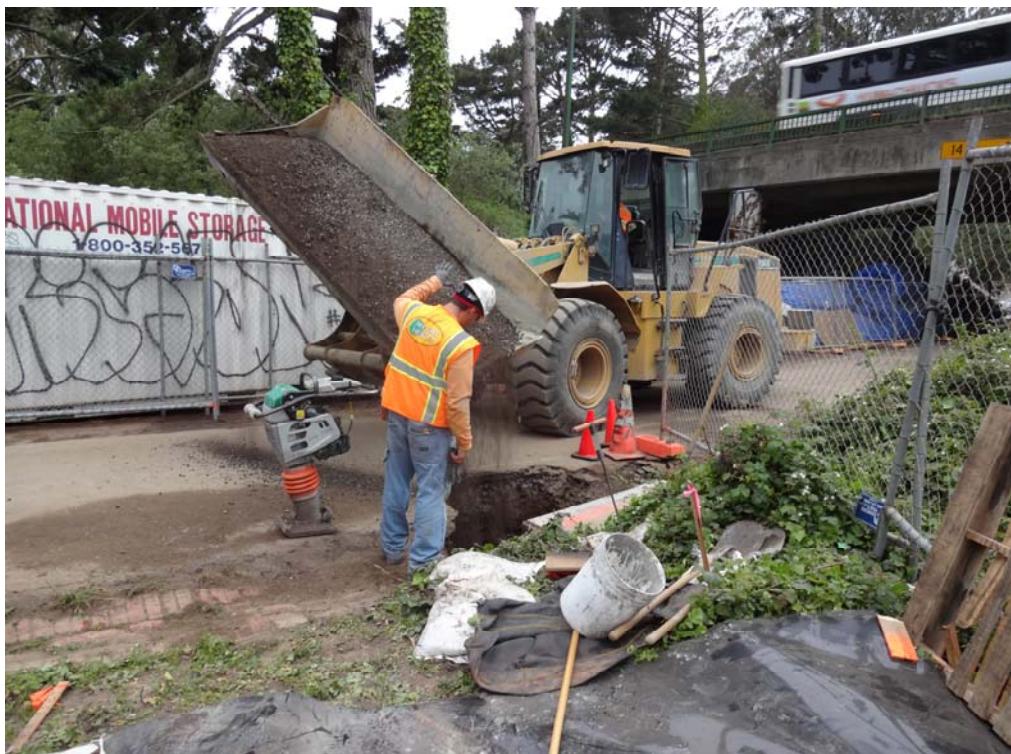
Photo #27: 4-25-2013. Caltrans contractor repairing drain near MHA.

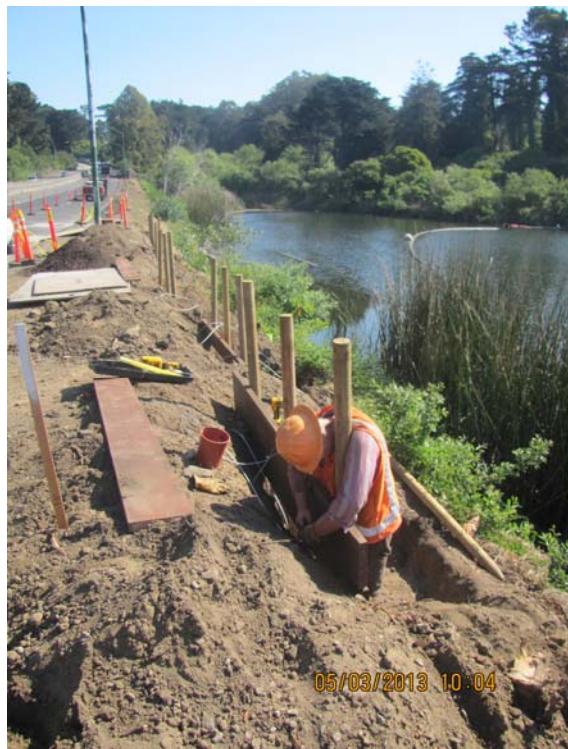
Photo #28: 5-3-2013. Caltrans contractor working along Park Presidio Blvd.

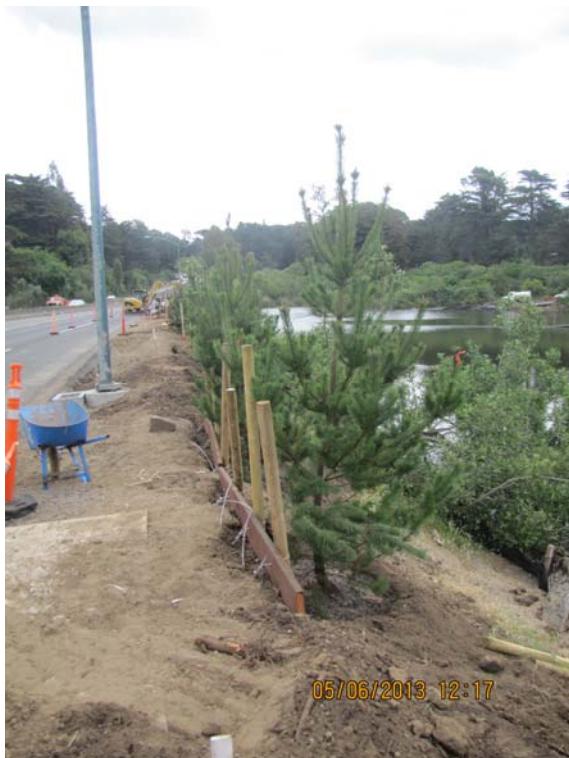
Photo #29: 5-6-2013. Caltrans contractor working along Park Presidio Blvd

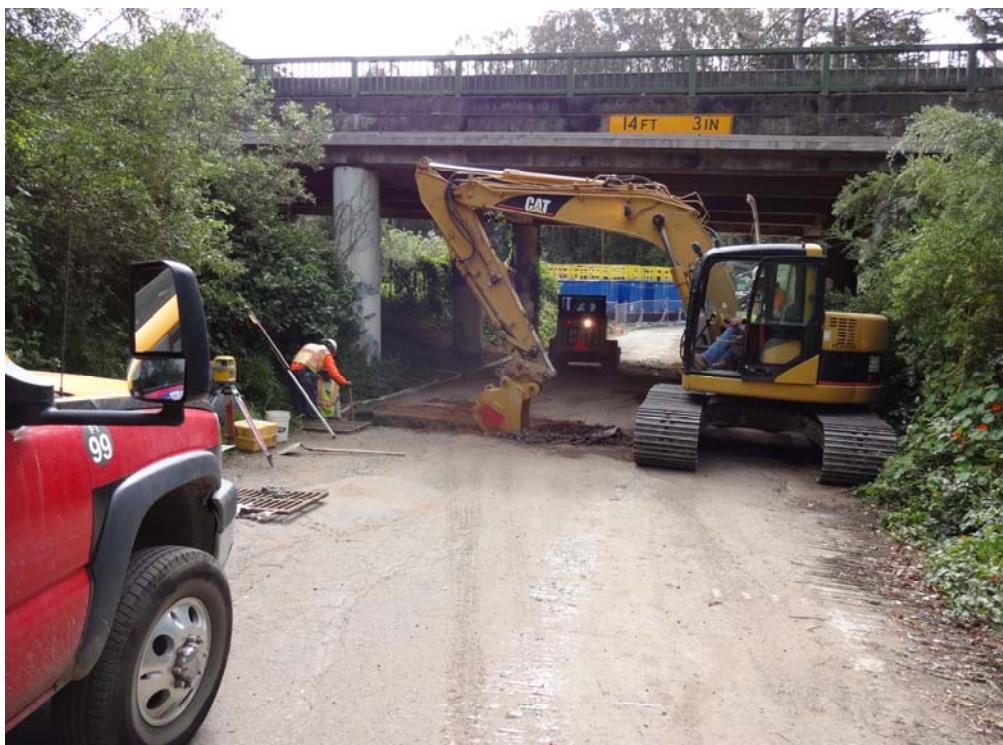
Photo #30: 6-17-2013. Caltrans contractor working on cross drain.
